**HOPETOUN PARK NORTH  
RESIDENTIAL DEVELOPMENT**

**GEOTECHNICAL INVESTIGATION FOR HOPETOUN  
PARK ROAD**

**REPORT NO V2211-2R2, MAY 2023**

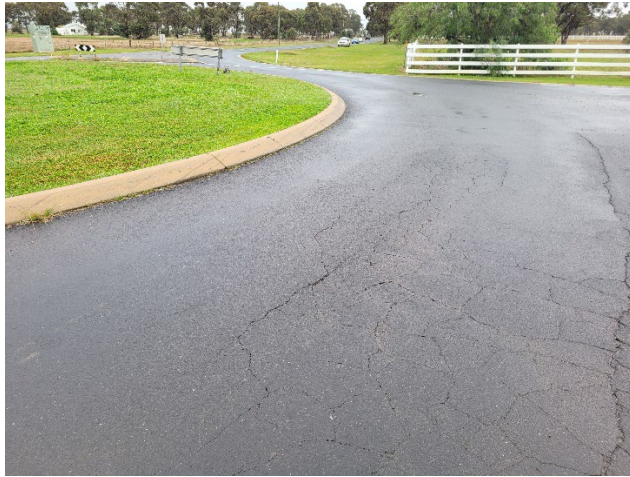
Whereas, the sprayed seal is in an excellent condition, the asphalt in the south end roundabout is cracked with widespread 'crocodile' cracking with some line and edge cracking.

*Image 3 – crocodile cracking, east side of roundabout, with some line cracking*

Crocodile cracking can be due to a number of causes including excess loading (turning single axle buses transmit high loads to the pavement), a weak subgrade, poor drainage, poor construction, temperature effects, and so on. The distress is usually due to a combination of causes.

Cracks should be repaired before on-going traffic and rainfall make the surface start to unravel and potholes develop.

Before any repairs are undertaken, it is recommended that the pavement thickness, make-up and subgrade strength are determined to confirm, or otherwise, that surface repairs will be effective. If it is determined that repairs are appropriate, a specialist pavement contractor should be consulted.

The cause of the asphalt surface cracking in the south end roundabout should be investigated and the asphalt repaired.

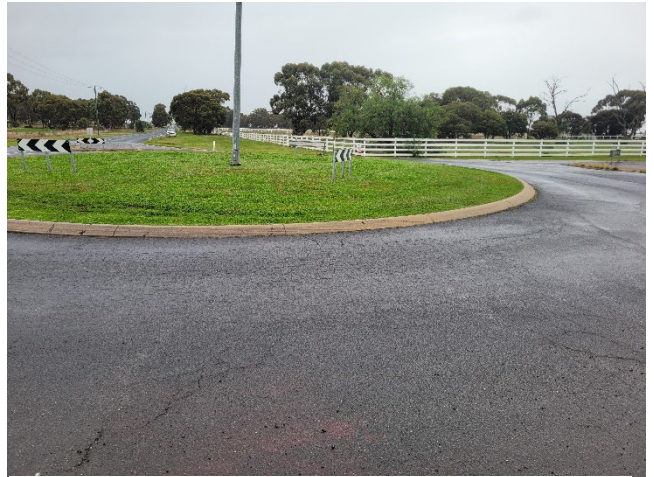
*Image 4 – crocodile cracking, south side of roundabout looking north*

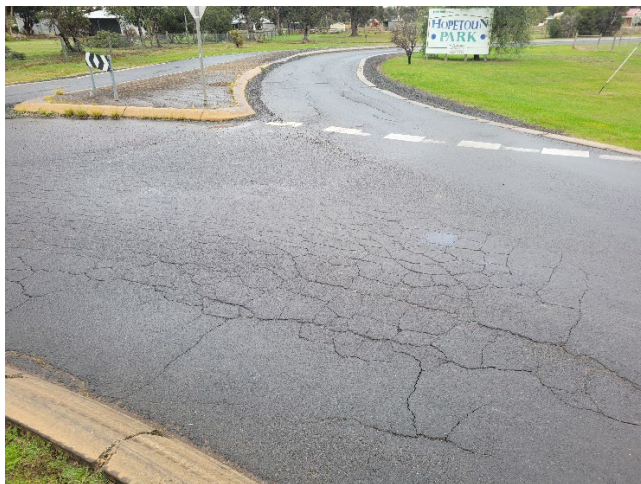
*Image 5 – crocodile cracking, south west side of roundabout*

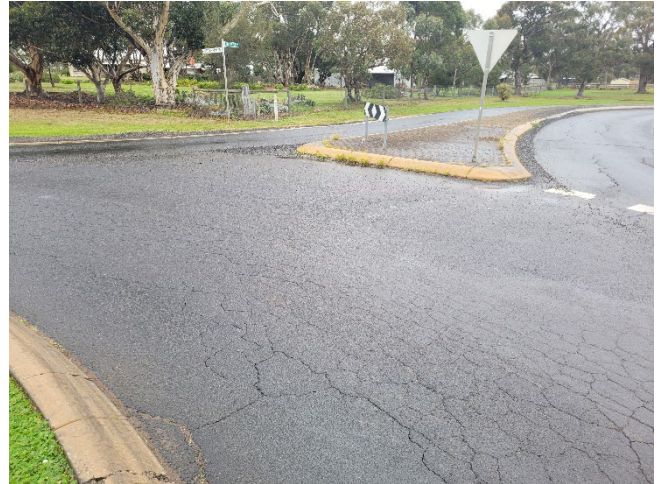
*Image 6 – crocodile cracking, south side of roundabout*

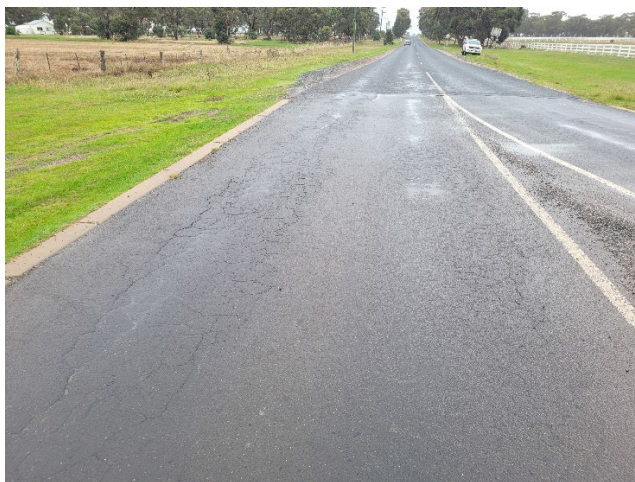
*Image 7 – crocodile cracking, northbound lane immediately north of roundabout*

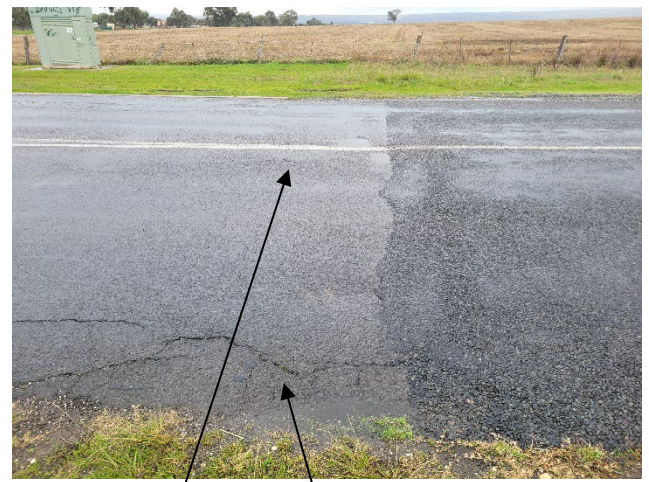
*Image 8 – crocodile and edge cracking, southbound lane, north of roundabout where the asphalt abuts the sprayed seal*

It should be noted that at the location where the sprayed seal meets the asphalt surface, it is highly likely that the flexible pavement thickness, makeup, and subgrade type and strength, are identical. However, at this location, the sprayed seal is in an excellent condition and the immediately adjoining asphalt surface is cracked.

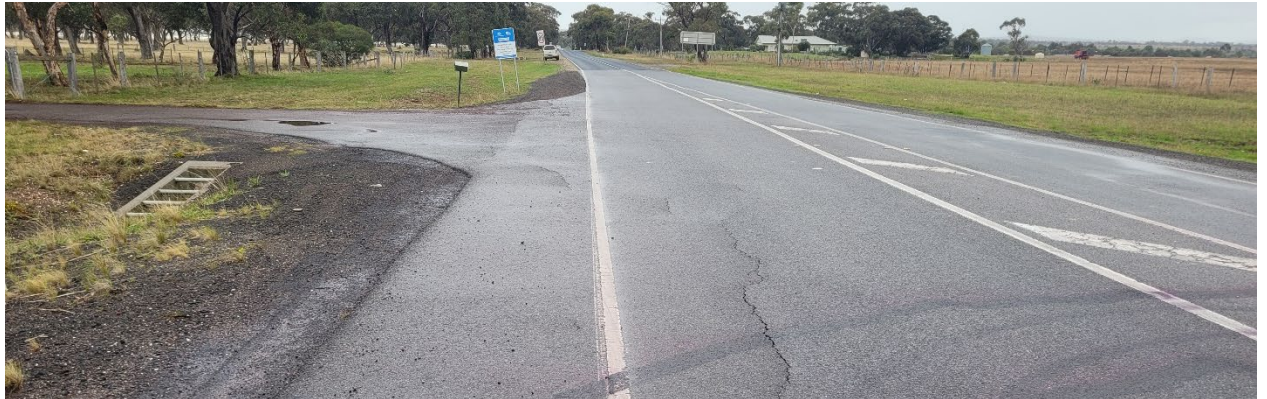
The north end asphalt surface is also cracked, but not to the extent of the south end, and the north end cracks are mainly longitudinal, not crocodile.

*Image 9 – line cracking in asphalt at north end. The sprayed seal can be seen as the darker pavement to the south*

The line cracking at the north end of the road is most likely due to reflection cracking from the CTCR base course. To limit future damage, a specialist pavement contractor should be consulted, and the cracks repaired.

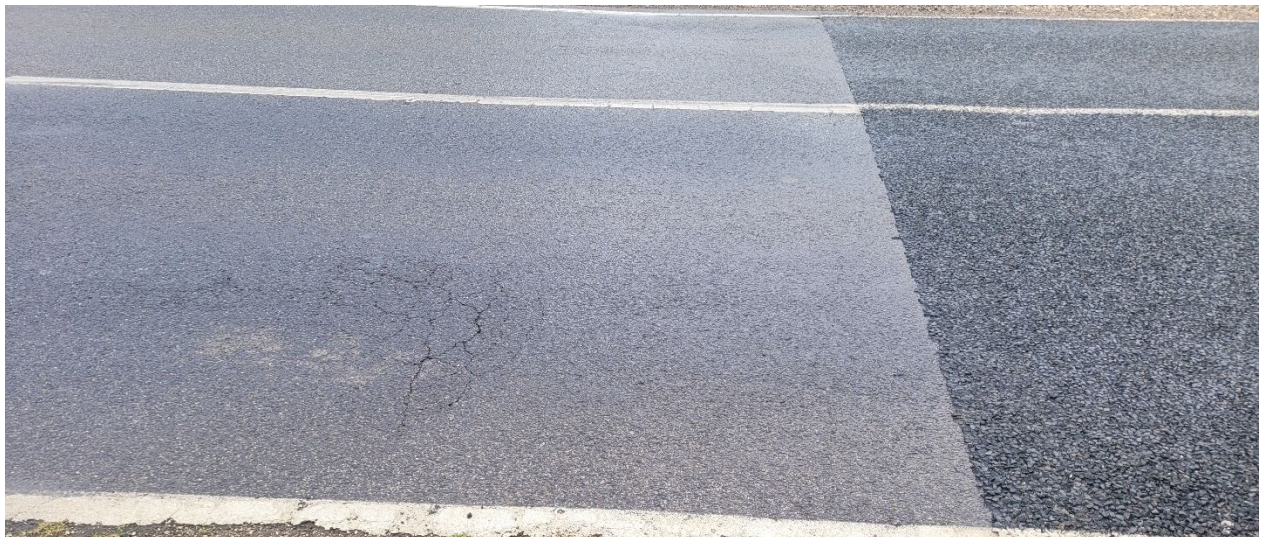
*Image 10 – minor crocodile cracking in asphalt at north end and also showing the adjoining sprayed seal pavement*

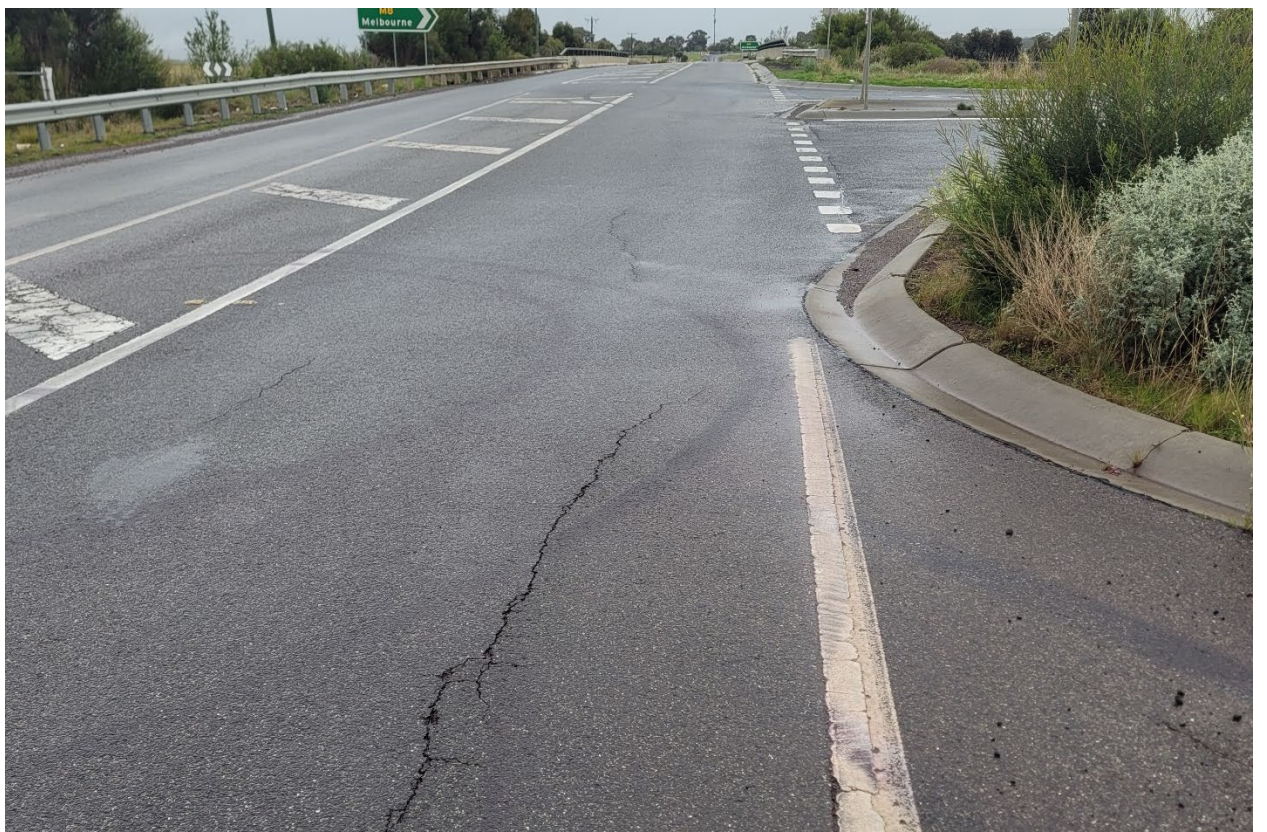
*Image 11 – line cracking in north end asphalt, looking north*

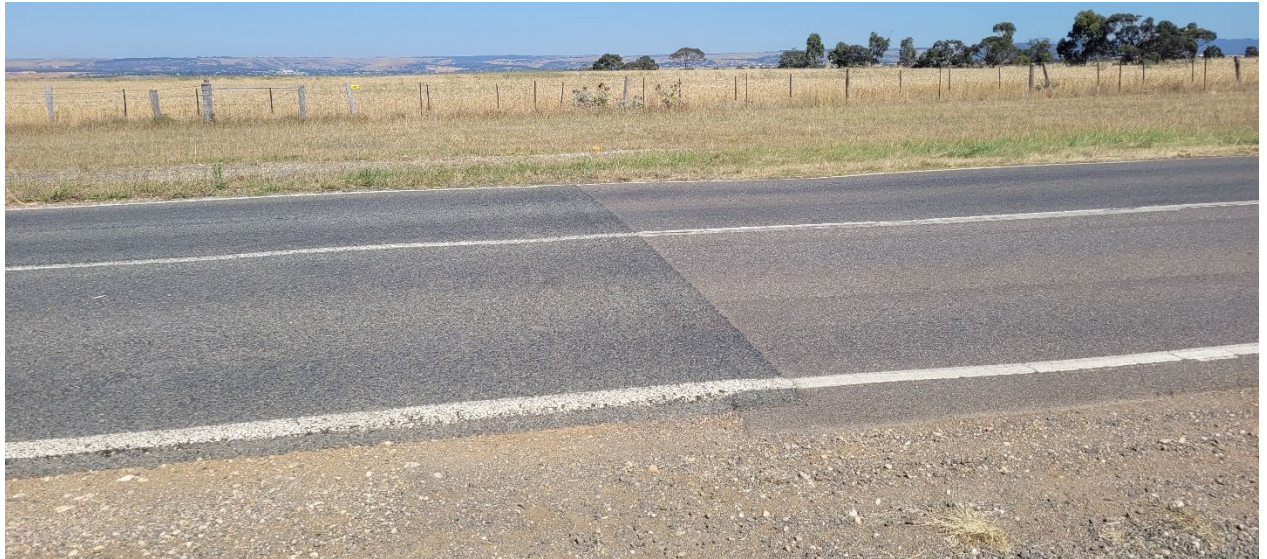
*Image 14 – Change of pavement makeup about 100 m south of the Western Freeway, with the asphalt seal and cement treated crushed rock base on the right*

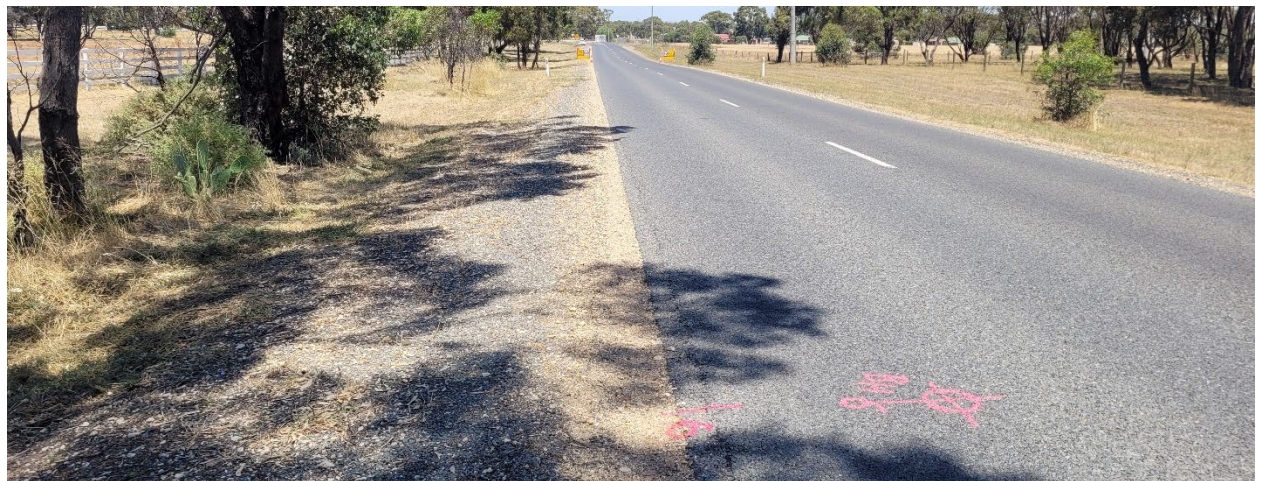
*Image 15 – Edge of pavement near BH06 showing the overlay seal*

It is noted that in the 20 year, or so, pavement life to date, there has been at least one additional seal applied, and it may be necessary to reapply the seal from time to time as per normal maintenance practice.

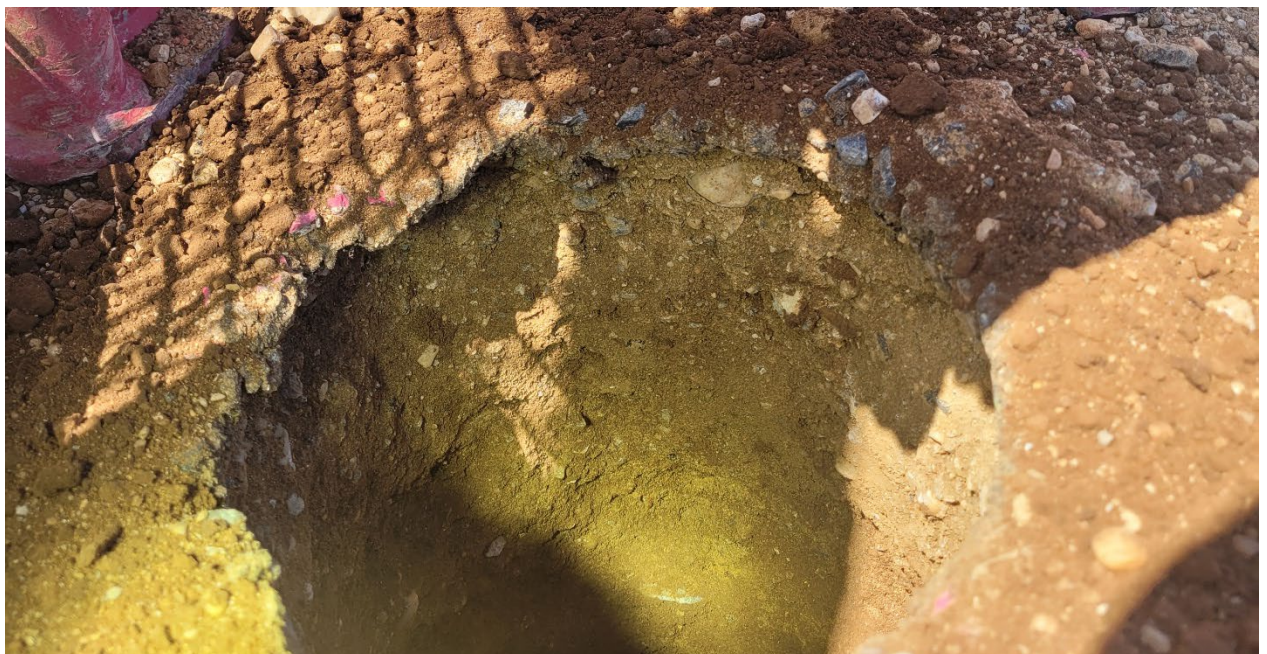
*Image 16 – Sprayed seal and pavement gravel in BH03.*
