**HOPETOUN PARK NORTH  
RESIDENTIAL DEVELOPMENT**

**GEOTECHNICAL INVESTIGATION FOR HOPETOUN  
PARK ROAD**

**REPORT NO V2211-2R2, MAY 2023**

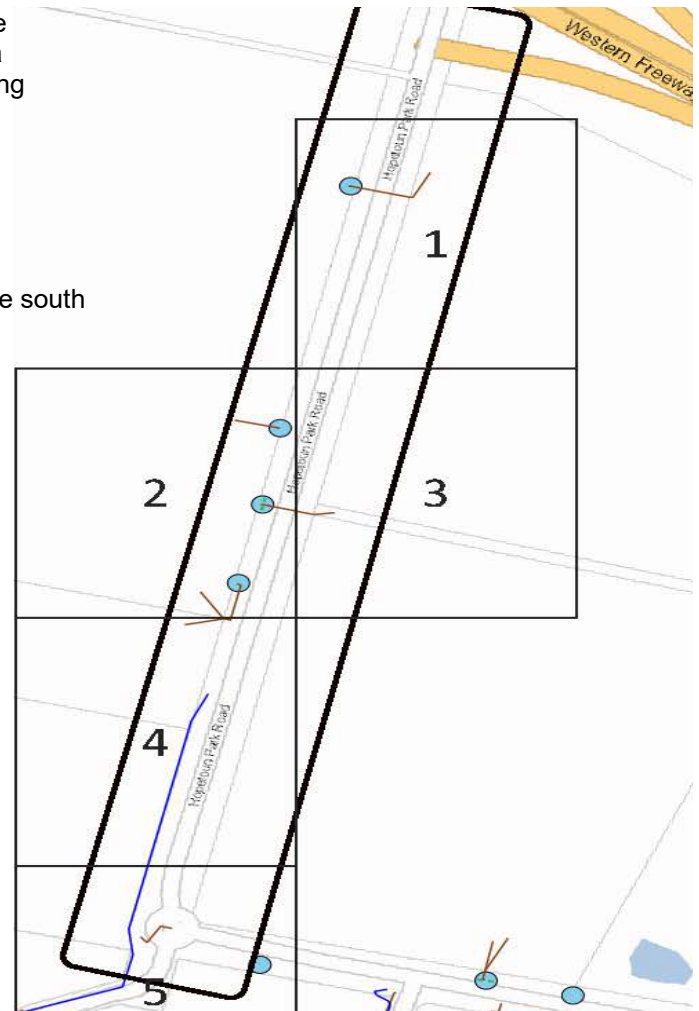
There is a high voltage underground cable at the south end of the western side of the road reserve.

Image 12 - Powercor cable plan. North is to the top of the image

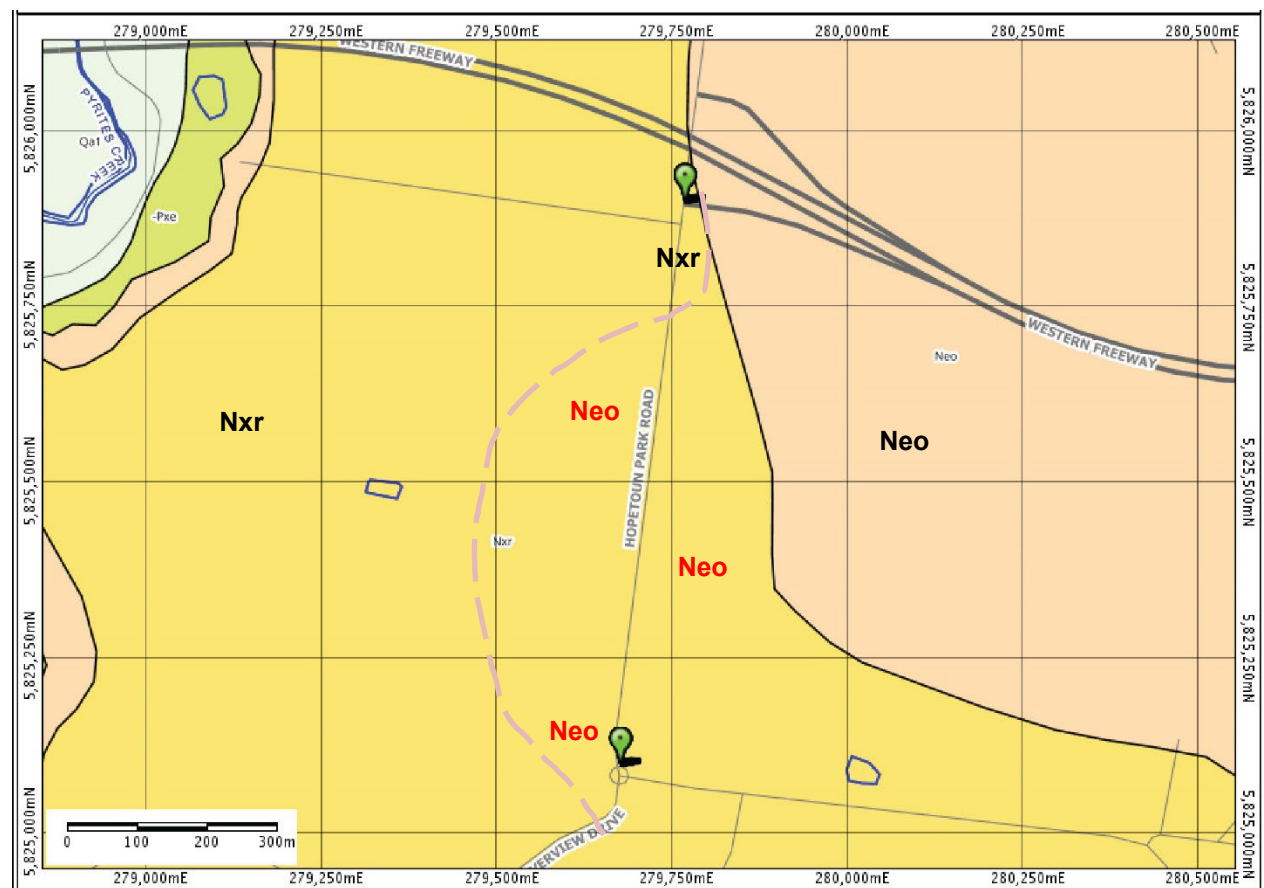
Image 18 – GeoVic3 extract. Hopetoun Park Road is between the two green teardrops.

However, as discussed in Section 2.4, it appears that, apart from the north end, most of Hopetoun Park Road is within the Newer Volcanics (Neo). The north end appears to be within the Darley Formation (Nxr). A suggested boundary between the two formations is shown as the dashed pink line in Image 18.
