Heritage Insight P/L

Our Ref: 1825

# RE: Subdivision of Lot A/PS821090 at Halletts Way, Bacchus Marsh: Aboriginal Heritage

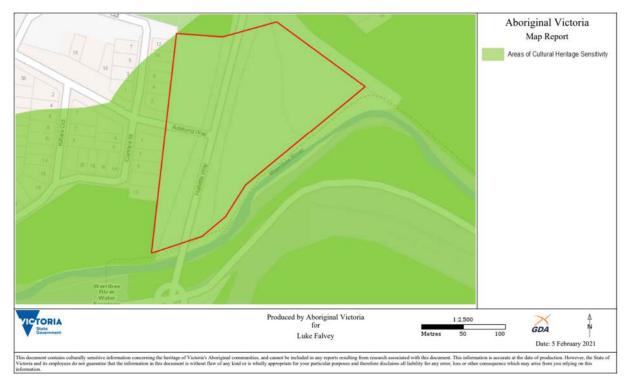
Figure 2: Showing area of cultural heritage sensitivity across the study area.

The study area is within an area of cultural heritage sensitivity as defined by regulation 26 (waterways) (Figure 2):

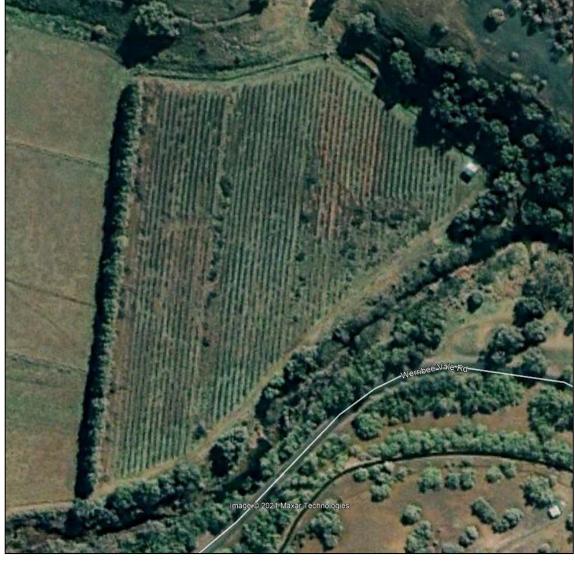
Figure 3: 2002 Google Earth aerial image of the study area

A 2002 aerial image (Figure 3) shows that the study area in 2002 was a vineyard. It is common knowledge that deep ripping of soils is a key component of soil preparation for a vineyard. A 2005 report from the Agricultural Machinery Research Design Centre, University of South Australia, to the Australian Government Grape and Wine Research and Development Corporation summarises the need to deep rip as follows (see also Cass et al. 1995 for further information on deep ripping:

Figure 3 shows that the entire study area (i.e., proposed lots A, B, C, D and E) was formerly a vineyard. Deep ripping of the study has likely occurred as part of the establishment of the vineyard as this is standard industry practice. Deep ripping meets the definition of disturbance to the topsoil by machinery and as such this event, in the first instance, has caused significant ground disturbance to the study area.

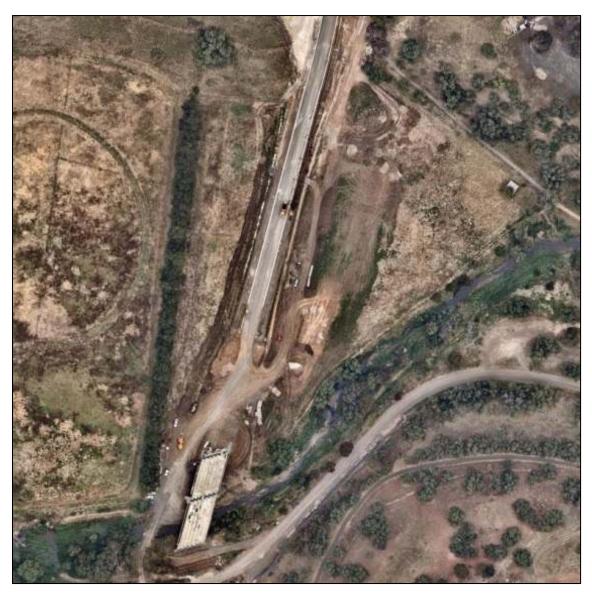
Figure 4: 2016 Nearmap aerial image of the study area

In December 2016, the initial cuts had been made for the road (Figure 4). These works impacted land to the east end of the road extension, across proposed lots D and E, but not to the whole of these areas at that time. By March 2017 however, a large portion the study area to both the east and west of the roadway had been stripped and crushed rock laid on the ground surface (Figure 5). Figure 6 shows the study area on either side of Halletts Way after works were completed in August 2017. The entire ground surface on the east side of Halletts Way (proposed Lots D and E), and most of the ground surface on the west side (proposed Lots A, B and C), has been disturbed by the road construction works. A small area of land in the NW corner of proposed Lot A remained undisturbed during this phase of disturbance.

Figures 4 and 5 show machinery carrying out earthworks across the study area. It is unclear why large parts of the study area were stripped during these road construction works but these works quite clearly meet the definition of disturbance to the topsoil by machinery in the course of grading and excavating and as can be seen in Figure 6 most of the study area was subject to significant ground disturbance at this time.

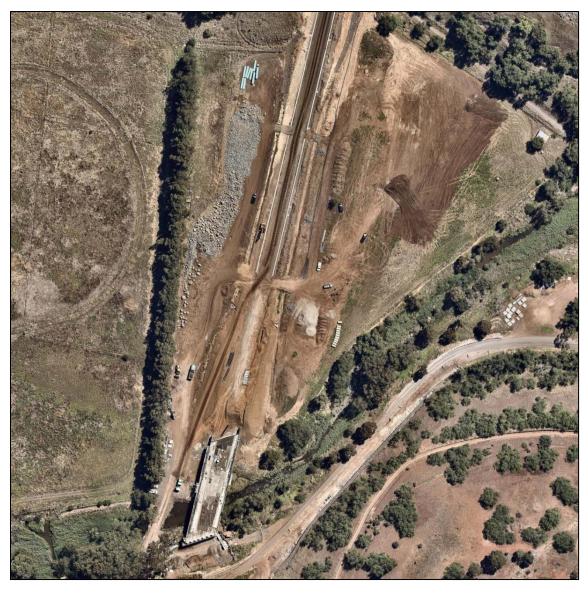
Figure 5: March 2017 Nearmap aerial image of the study area

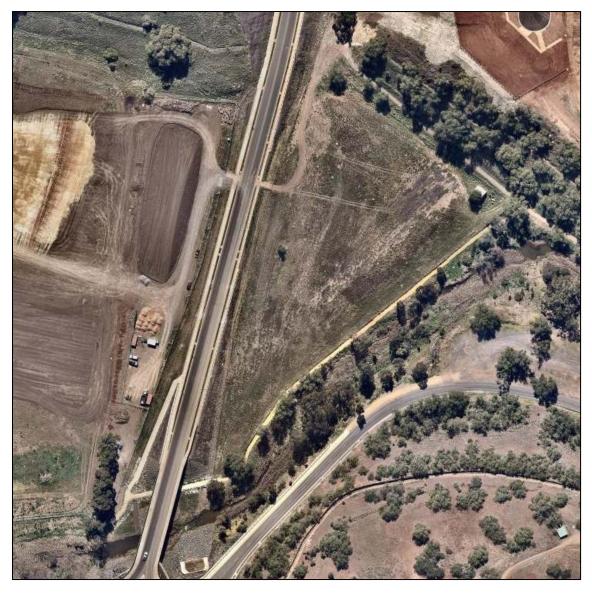
Figure 7: September 2018 Nearmap aerial image of the study area

In September 2018, proposed Lots A, B and C were stripped and used as stockpiling areas, laydown areas, site sheds and construction yards (Figure 7). By May 2019 these construction areas cover the entirety of proposed Lots A, B and C and have encroached on the western part of proposed Lots D and E (Figure 8). By October 2019 these areas had been cleaned up and the topsoils reinstated (Figure 9).

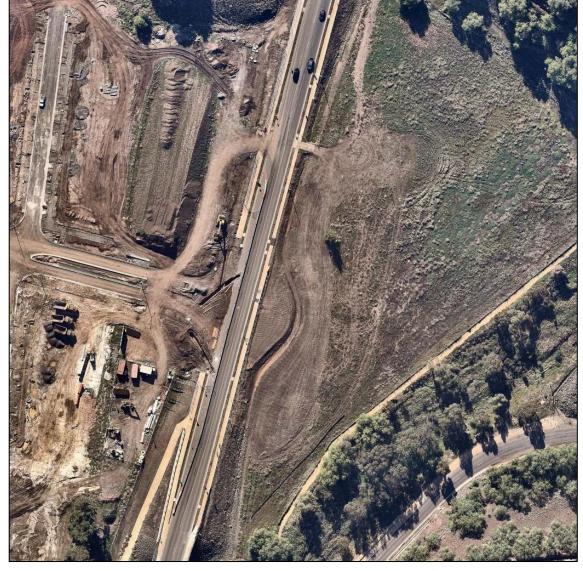
Figure 8: May 2019 Nearmap aerial image of the study area
